Tips from the gasket expert

Engine failure – is the cylinder head gasket to blame?

Overheating of the metal/soft-material cylinder head gasket

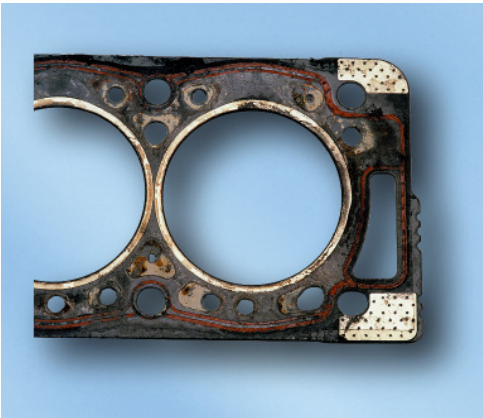
Damage symptoms:

The exposed soft materials on the gasket are heavily swollen at the water passages.

Cause:

After installation of the engine, the cooling system was not vented sufficiently. The engine overheated because of excessive coolant temperature. Vaporization led to the swelling of the soft material of the gasket in the area of the water duct, thus separating the soft material of the gasket from the metal carrier.

Other possible causes:

- The function of the cooling circuit was restricted by water pump or thermostat
- Water circulation in the cooling system (e.g. in the radiator) was restricted due to calcium deposits
- Using of coolant which is not authorised by the engine manufacturers

Measures:

After installation, ensure that the air is vented fully from the cooling system.
